# Wanapum Dam Spillway Fracture

May 20, 2014

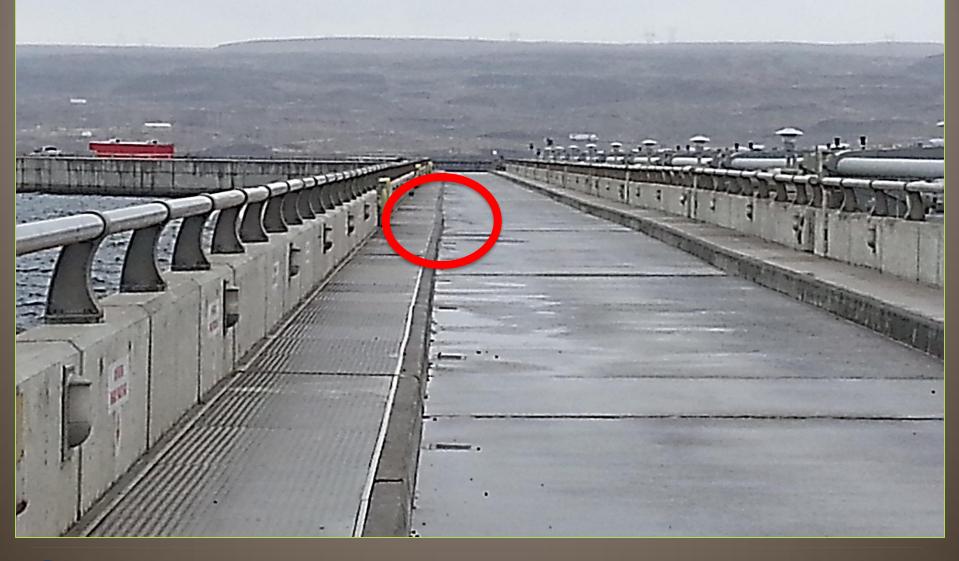
#### WANAPUM DAM (looking east from the right bank on the spillway deck)

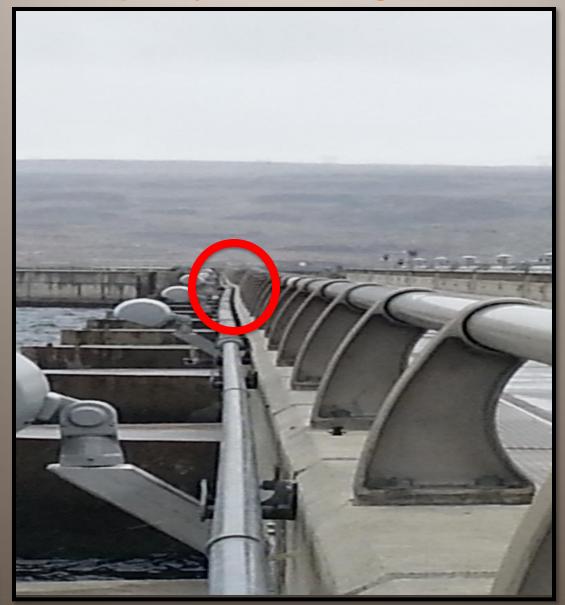
#### **Spillway Deck, looking east**

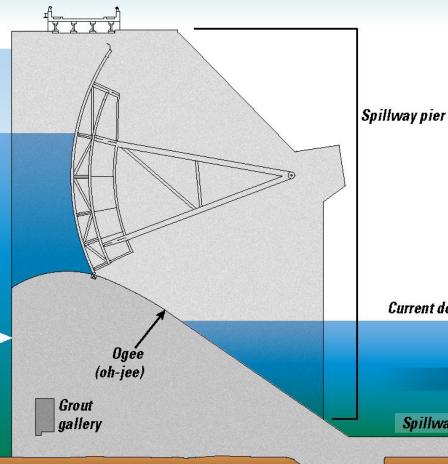
## **Wanapum Dam**

Cross section of damaged concrete pier Number 4.

#### Normal upstream water level

(562 - 571 ft. above sea level)

#### Current upstream water level

(541-545 ft. above sea level)

Water flow

Fracture Location -

Roadway

Current downstream water level

Spillway apron

Bedrock
